Kingbarrow Quarry, Portland.

The problem.

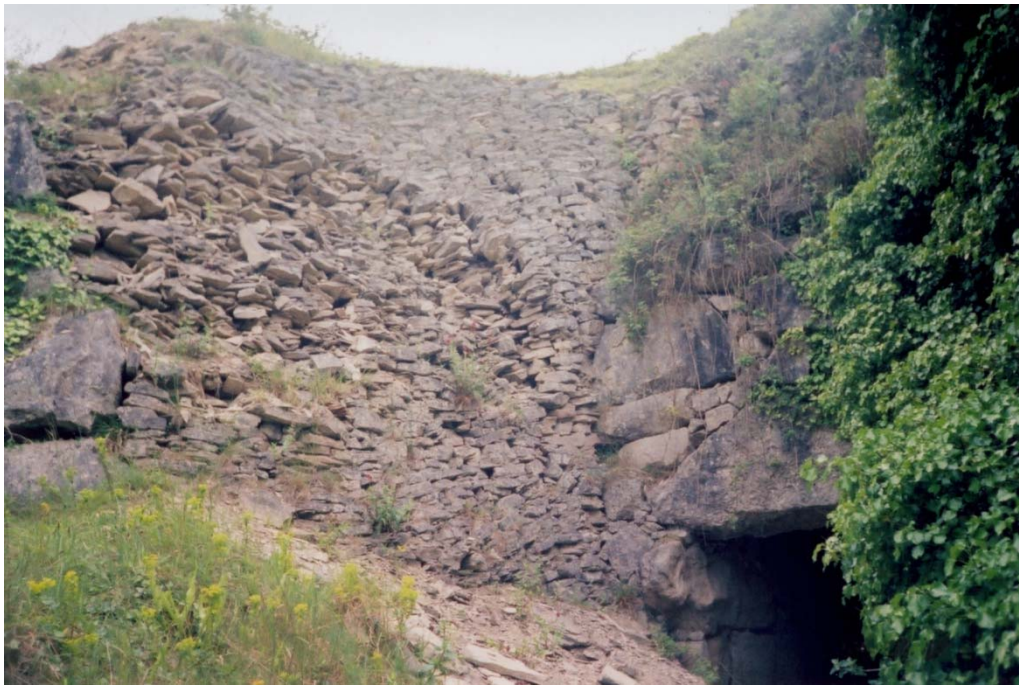
Kingbarrow Quarry on the Isle of Portland in Dorset is a SSSI containing rare fauna, flora and fossils. A nature trail was planned to take the public around the quarry often through narrow paths hemmed by high spoil heaps contained by dry stonewalls. Consulting Engineers, Jacob Babbie undertook a study of the quarry and identified that many of the dry stone wall 'skins' were collapsing and unsafe.

A typical section of collapsing dry stone retaining wall

- Loose rock was carefully picked off and the area injected with grout to 'stick' blocks together.
- Collapsed walls were built back up using concrete filled sand bags to give a strong long lasting structure.
- The new walls were anchored into the spoil behind using hollow self drilling anchors allowing grout to be injected deep into the fabric of the spoil.
- Finally, rock netting was secured using additional anchors and reinforced by tensioned steel cables.

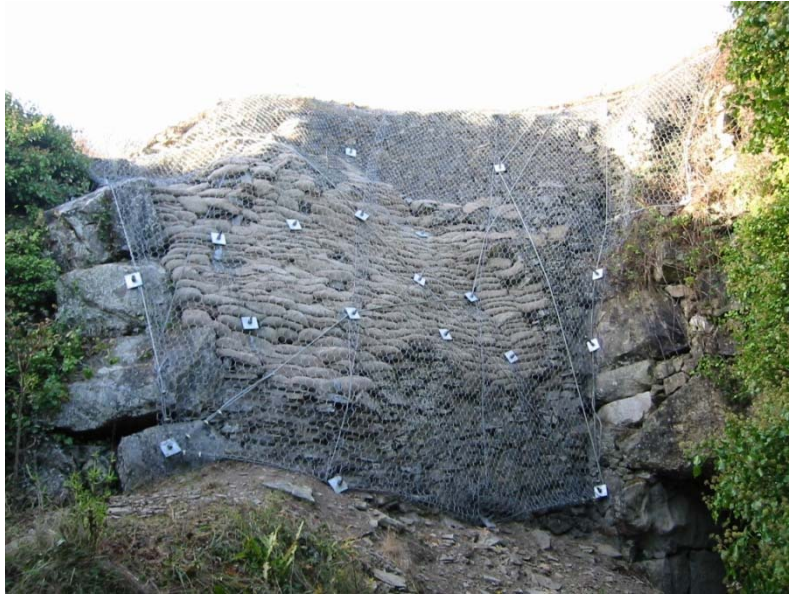
Stabilised dry stone retaining wall

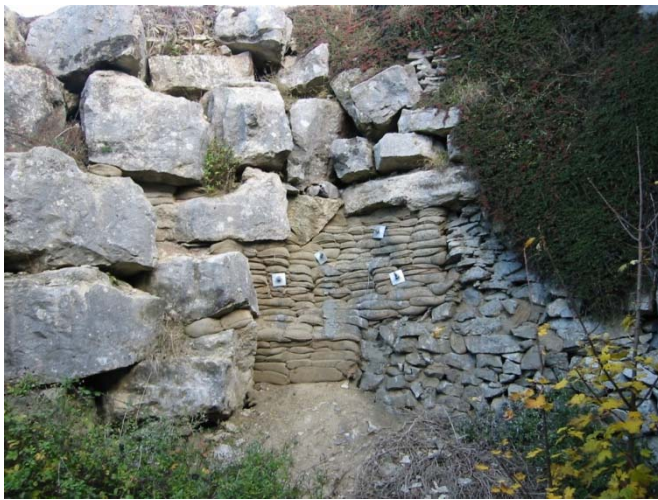
Other areas required temporary propping to allow safe access, dentition and hollow anchors

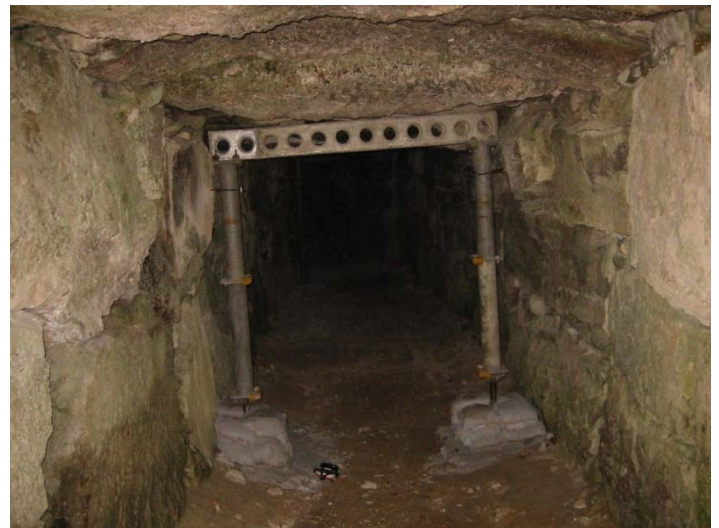
Access tunnels were assessed and where necessary, reinforced with props.
